The Tay rail bridge disaster — a reappraisal based on modern analysis methods

T. Martin, BSc, and I. A. Macleod, BSc, PhD, FICE, FStructE

The collapse of the world's longest bridge in 1879 with the loss of 75 lives exposed a major weakness in British civil engineering. While American and French engineers were using significant wind loadings, few of their British counterparts even considered it. But there is still speculation as to exactly why the first Tay rail bridge in Scotland failed and as to whether its designer, Sir Thomas Bouch, was to blame. This paper, based on a recent three-dimensional computer analysis using a modern approach to wind loading, throws new light on the collapse.

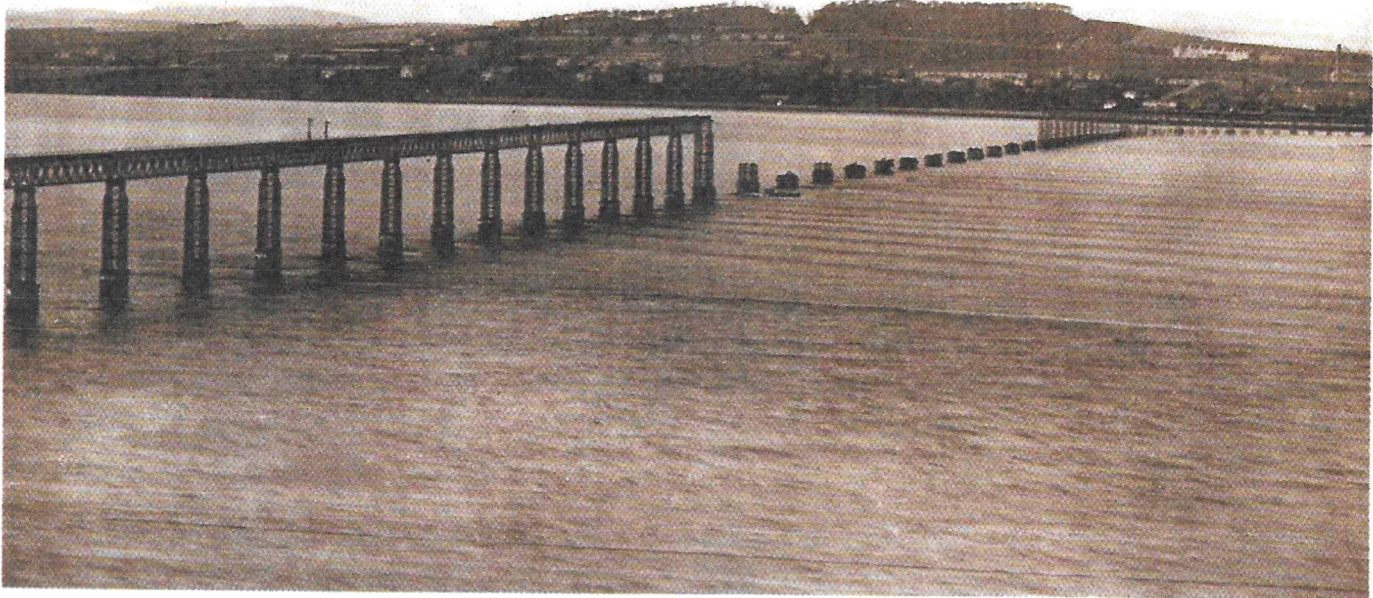
Fig. 4. Tay rail bridge after 1878 collapse (viewed from south)

The disaster occurred on the stormy night of 28 December 1879. A train of one engine and six carriages crossing the bridge from the south to north was lost when the structure of the navigation spans section collapsed (Fig. 4). Detailed accounts of the disaster are given by Thomas¹ and Prebble². There were no survivors from the 75 people aboard the train. The gale blowing along the Tay estuary at right angles to the bridge was estimated at force 10 to 11 on the Beaufort Scale by local naval officers. Local amateur meteorologists also reported that the train was crossing the bridge about the time the gale was at its peak.³

On the basis of these observations a scenario for the collapse is as follows. When the train reached the high girders there was a particularly strong gust. The presence of the train increased the overturning effect marginally and the bolts in the windward columns of the piers came into tension. Because they were intended for location purposes rather than to take tension they were not fully anchored into the masonry of the pier. The column bases started to lift off taking two courses of masonry with them (Fig. 7). This had the beneficial effect of reducing the loads in the baseplate bolts but caused a significant increase in the diagonal bracing members causing them to fail. These members first failed not at the bottom level but at a level above that. This triggered a toppling collapse with rotation tending to be at level 1 (Fig. 8). During the process of toppling there was a kickback to windward on the remains of the piers below level 1.

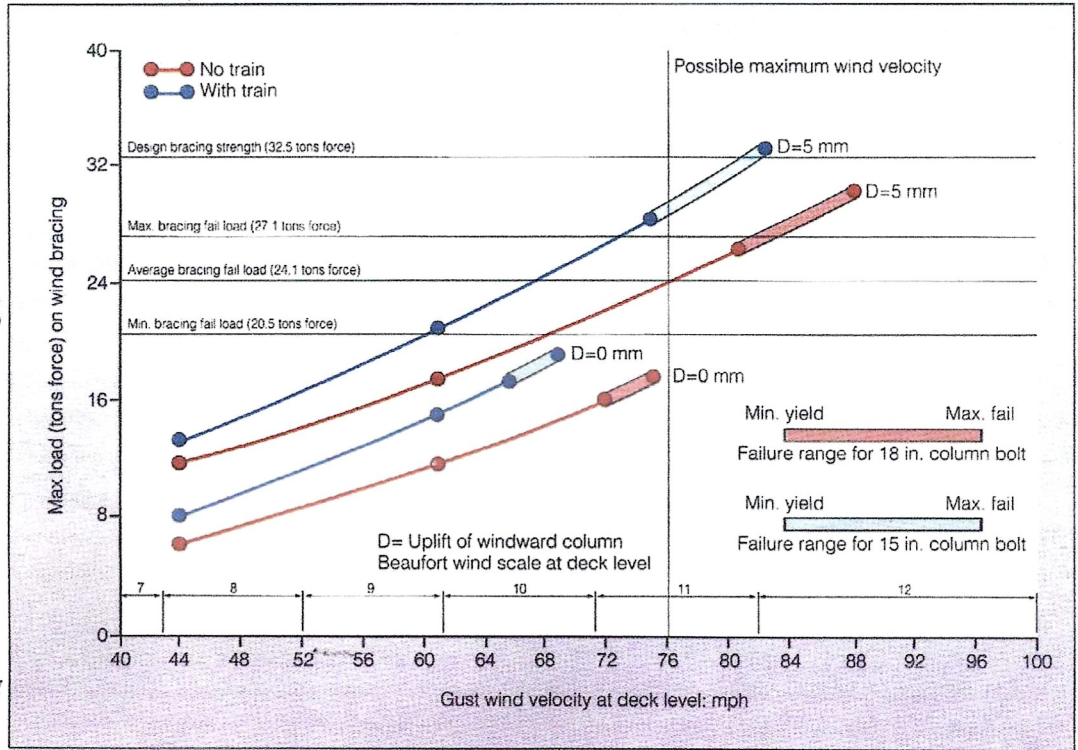
Fig. 6. Maximum bracing loads in relation to wind speed
(1 mile/h = 0.45 m/s,
1 ton force = 9.97 kN)

- *Whether or not the train was on the bridge* — the train appears to have had a significant effect on the overturning action.
- *Tensile failure of the column baseplate bolts* — these bolts were not expected to be in tension but Fig. 6 shows that failure could have occurred under force 10 conditions with no uplift.

- *Uplift of the windward column base* — this factor was not considered at the time of the original inquiry⁶ but it does have a significant effect on the bracing load. It is likely that this was the first step in the collapse. The 5 mm uplift used in Fig. 6 is based on an estimated weight of foundation resisting the applied load at a wind speed of 34 m/s (with no vertical restraint at the column base in the analytical model). Such a lift moves the likely column

- *Bracing strength* — the design strength of a bracing member in tension was 32.5 tons force (1 ton force = 9.97 kN) but measured strengths were less than this as shown in Fig. 6. The uplift of the windward columns significantly increases the bracing load. An important observation from the analytical results is that the

highest bracing load is not at the level above the base of the columns but at the next level up. This is due to the fact that the moment connection at the base of the column induces the column to take some of the base shear thus relieving the bracing load at the base.

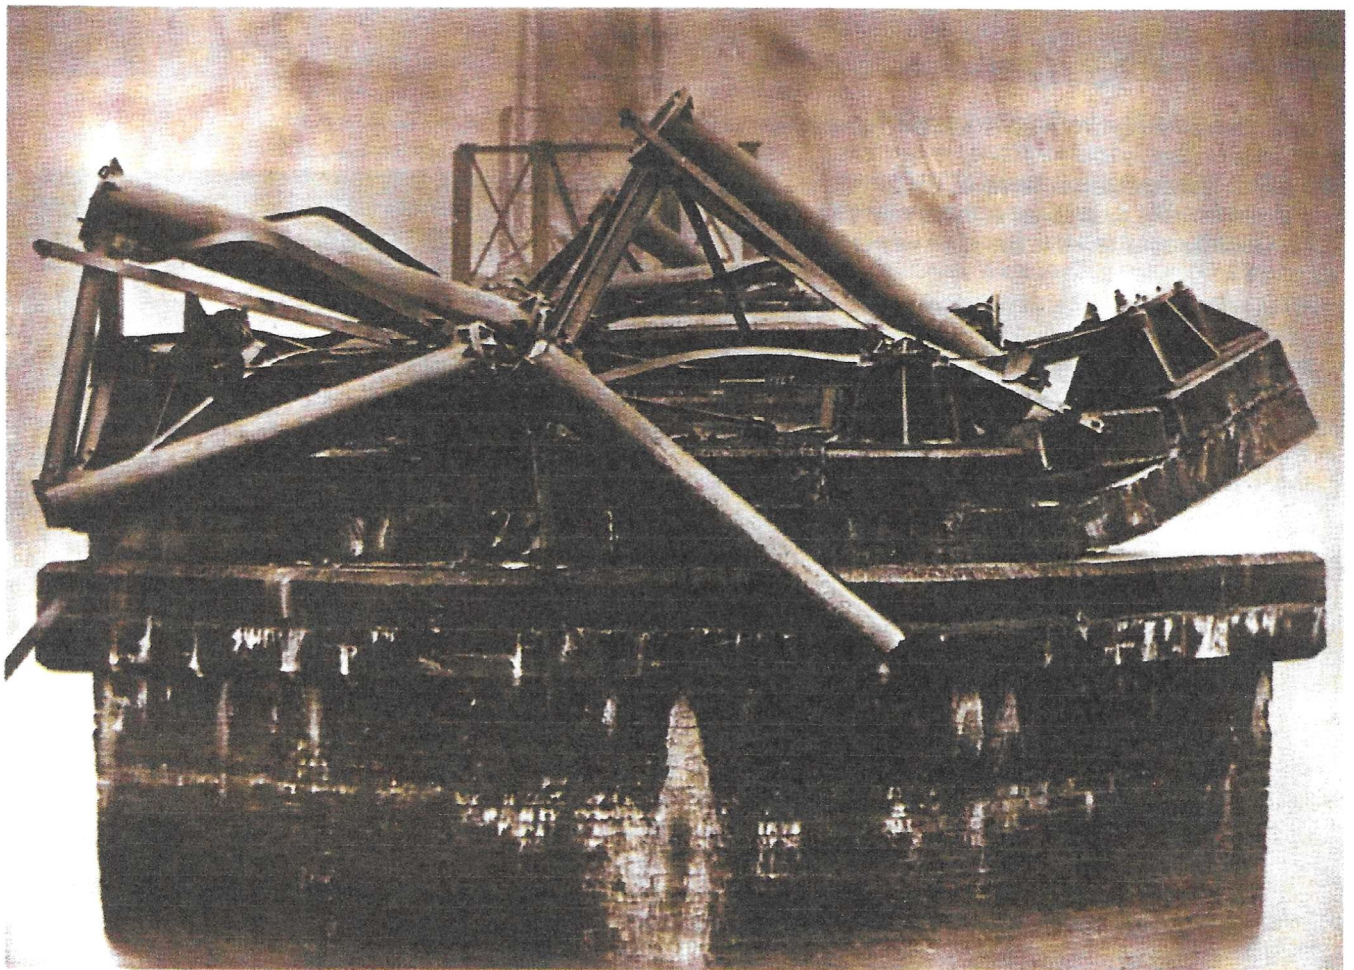
Fig. 7. Pier no. 33 after collapse showing lifting of masonry on windward side (right)

The scenario is in accord with pictorial records and with evidence given at the inquiry. Fig. 7 (where the windward side is to the right of the photograph) shows two courses of masonry having been pulled up by the column bolts. For two of the piers (29 and 31, the first and third navigation piers on the south side respectively) the base level bracing remained in place. The court of inquiry report,⁶ paragraph 12, says

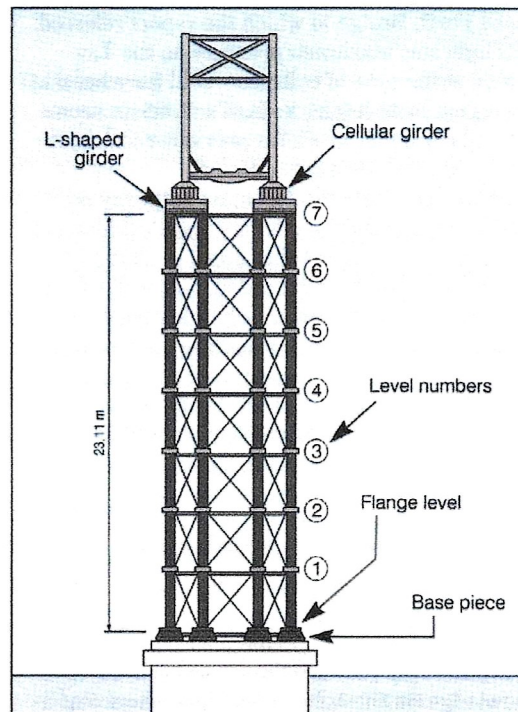
Fig. 8. Elevation of a typical navigation span pier.

suggests that Bouch may have compromised the strength and stability of the redesigned piers because the project was well over budget and behind schedule. This view is corroborated by the fact that Bouch had intended to use eight columns in rows of two (similar to the Belah Viaduct) instead of six columns in the shape of a hexagon.¹ Most engineers would feel empathy for his predicament. If the funding of the project had been more favourable it is likely that a stronger, more stable pier structure would have been built.
