The legacy of the Tay Rail Bridge Collapse

Iain MacLeod, Tom Martin

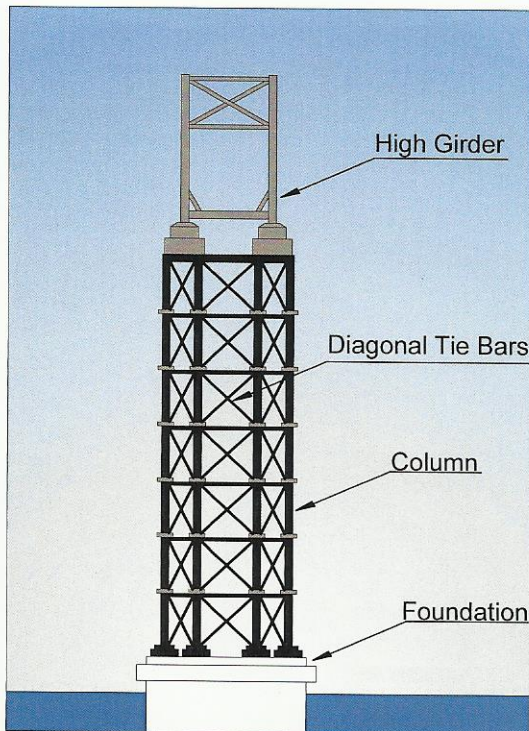
Figure 2. Elevation of a pier

To reduce the loading, he re-designed the piers as cast iron columns braced by wrought iron ties -Figure 2. This could have worked well but Bouch made several errors in specifying the new arrangement as discussed in the section that follows.

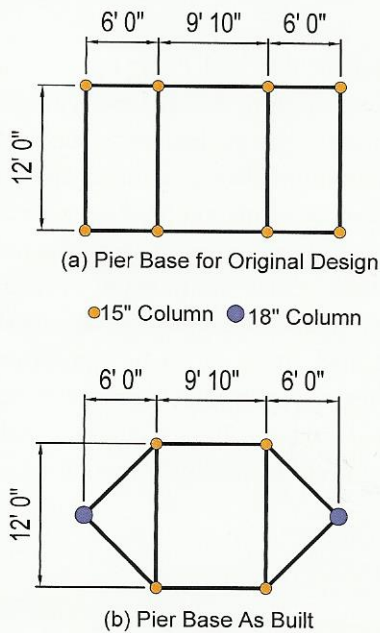
Figure 3. Layouts of columns for a pier

For an early design of the bridge, Bouch used an 8 column layout - Figure 3(a) - but in order to reduce the diameter of the caissons, and hence reduce the cost, he chose the 6 column layout with only single columns in the outer rows - Figure 3(b). For a layout of this type under lateral load, the

outer columns take the highest stresses and therefore the 8 column arrangement is significantly stronger and provides more stability. That would have been a much better choice.

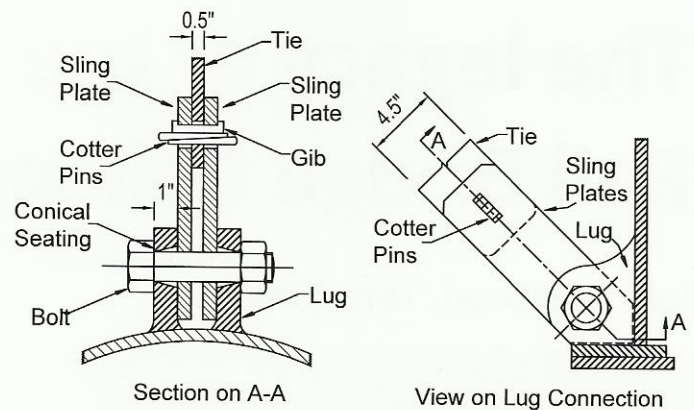
Figure 4. Tie bar connection

- The diagonal tie bars were connected to the columns by lugs that were cast with the columns - Figure 4. The bearing surfaces for the bolts on the lugs were as cast and were therefore uneven. There was no specification to ensure that these bearing surfaces were smooth. This was the most serious defect in the tie assembly. One does not need to be an engineer to understand that having an uneven bearing surface will increase the bearing stress.

- The stresses in the cast iron lugs were tensile. The tensile strength of cast iron is significantly lower than its compressive strength and the material is brittle. Wrought iron would have been a much more suitable material for making the connections to the columns.

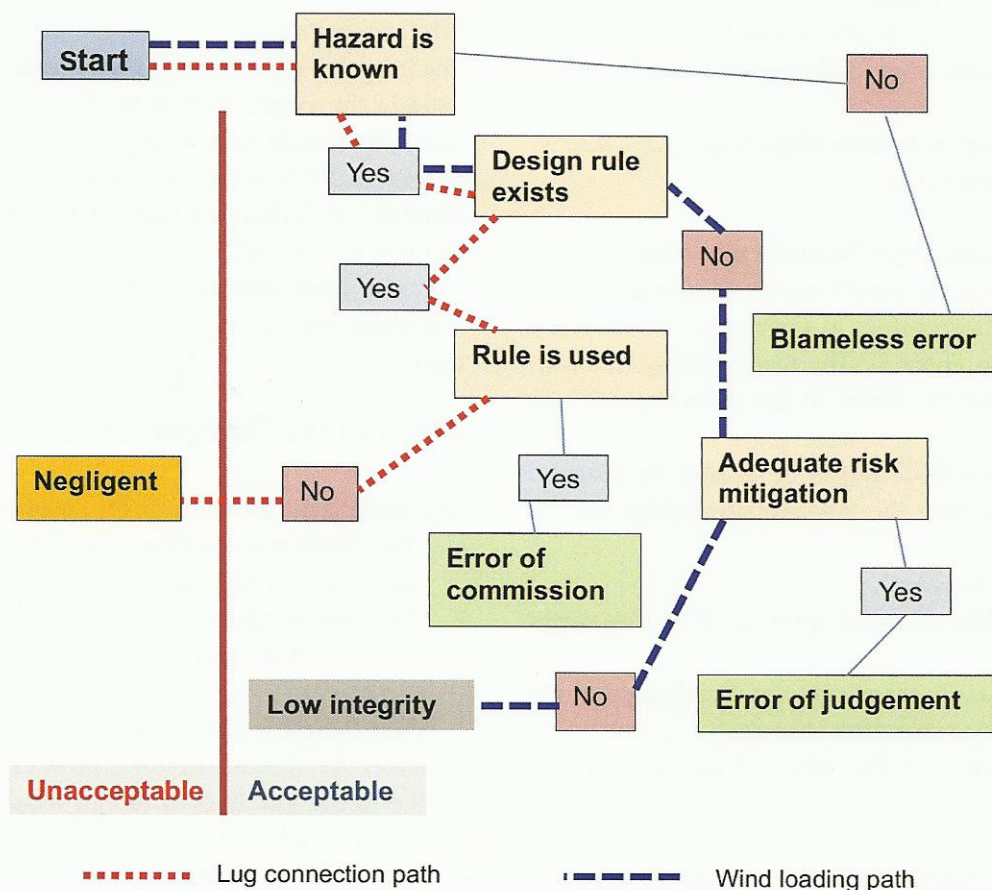
Figure 5. Design culpability

Figure 5 shows culpability paths for the two major faults of low wind force allowance and unsatisfactory specification of the lug detail.

Wind loading path culpability path - blue dashed line, Figure 5 That wind loading might be important was recognised but no design rules were available. Bouch's action to mitigate this risk was inadequate. He was dealing with a safety critical issue about which there was much uncertainty. He should have sought to err on the safe side but he did not. Therefore, one could infer that he steered a course towards being negligent but did not cross the line.

Design of the bracing assembly (red dotted line, Figure 5) That the ties were understrength and that the cotter

arrangement was unsatisfactory may have been due to errors of judgement or of commission but culpability for the errors in the design of the cast iron lugs on the columns was at a different level.
