The Tay rail bridge disaster — a reappraisal based on modern analysis methods

T. Martin, BSc, and I. A. Macleod, BSc, PhD, FICE, FStructE

The collapse of the world's longest bridge in 1879 with the loss of 75 lives exposed a major weakness in British civil engineering. While American and French engineers were using significant wind loadings, few of their British counterparts even considered it. But there is still speculation as to exactly why the first Tay rail bridge in Scotland failed and as to whether its designer, Sir Thomas Bouch, was to blame. This paper, based on a recent three-dimensional computer analysis using a modern approach to wind loading, throws new light on the collapse.

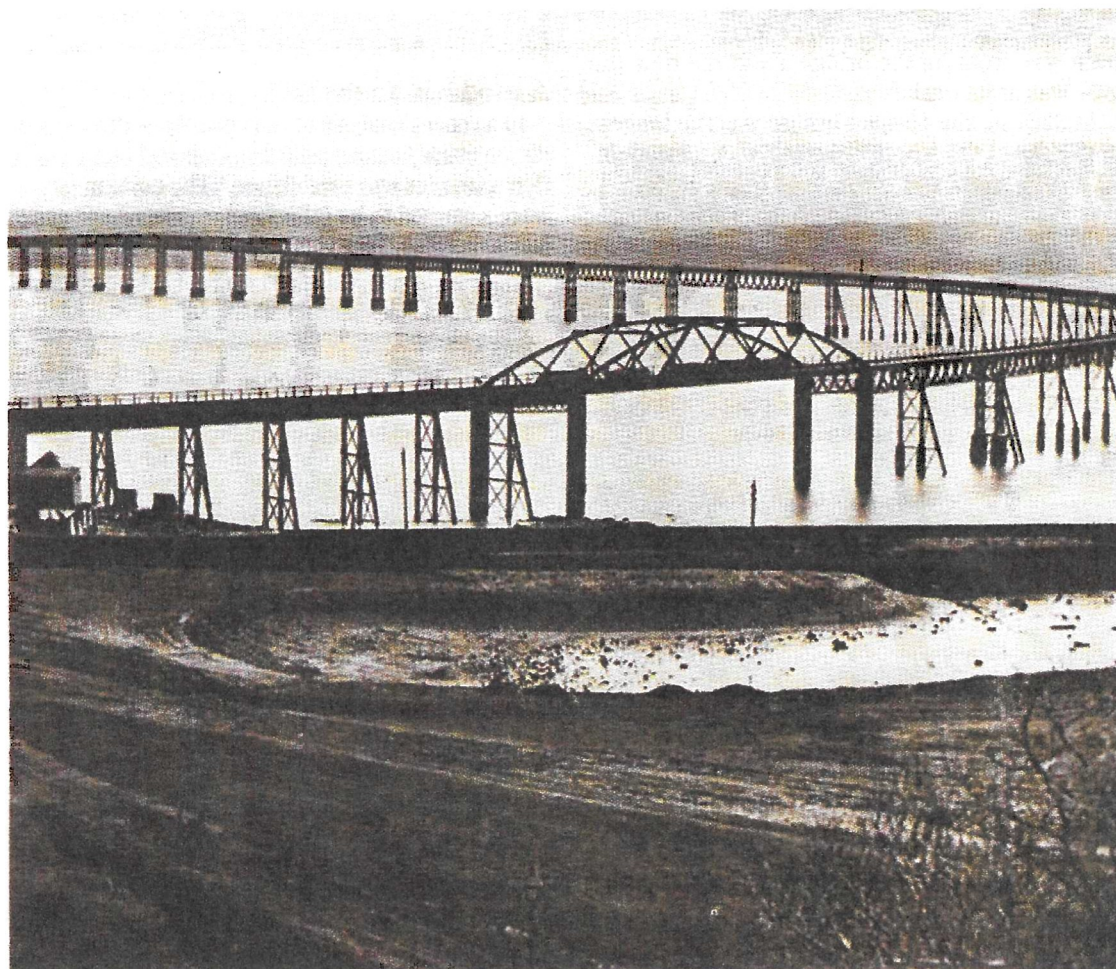
Fig. 1. First Tay rail bridge before collapse (viewed from north)

The first Tay rail bridge (Figs 1 and 2) was completed in February 1878 to the design of Thomas Bouch for the North British Railway Company. Bouch was responsible for the design, construction and maintenance of the bridge. He had made his reputation as a railway engineer

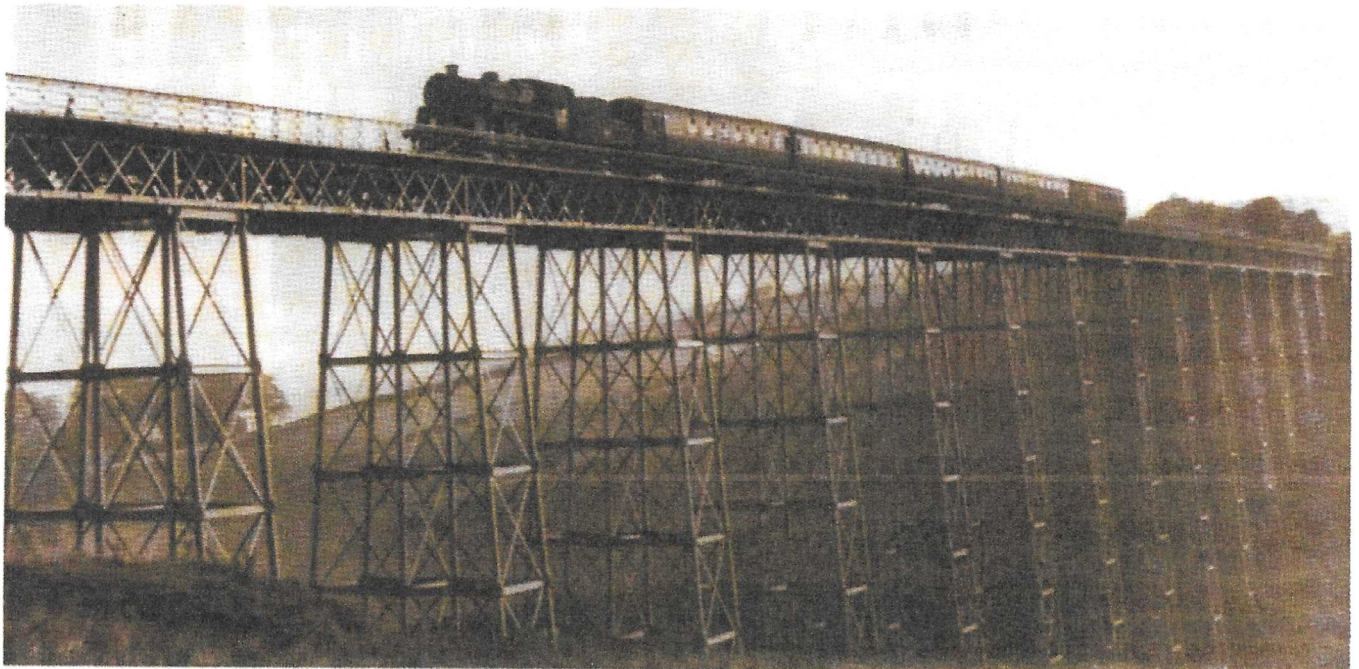
Fig. 3. Belah Viaduct, 1858

A key insight into the human cause behind the technical cause for the collapse of the bridge can be gained by comparing the design of the Belah Viaduct (Fig. 3) with the Tay Bridge. It is difficult to comprehend that both structures were designed by the same engineer. The court of inquiry in comparing the two structures reported

suggests that Bouch may have compromised the strength and stability of the redesigned piers because the project was well over budget and behind schedule. This view is corroborated by the fact that Bouch had intended to use eight columns in rows of two (similar to the Belah Viaduct) instead of six columns in the shape of a hexagon.¹ Most engineers would feel empathy for his predicament. If the funding of the project had been more favourable it is likely that a stronger, more stable pier structure would have been built.

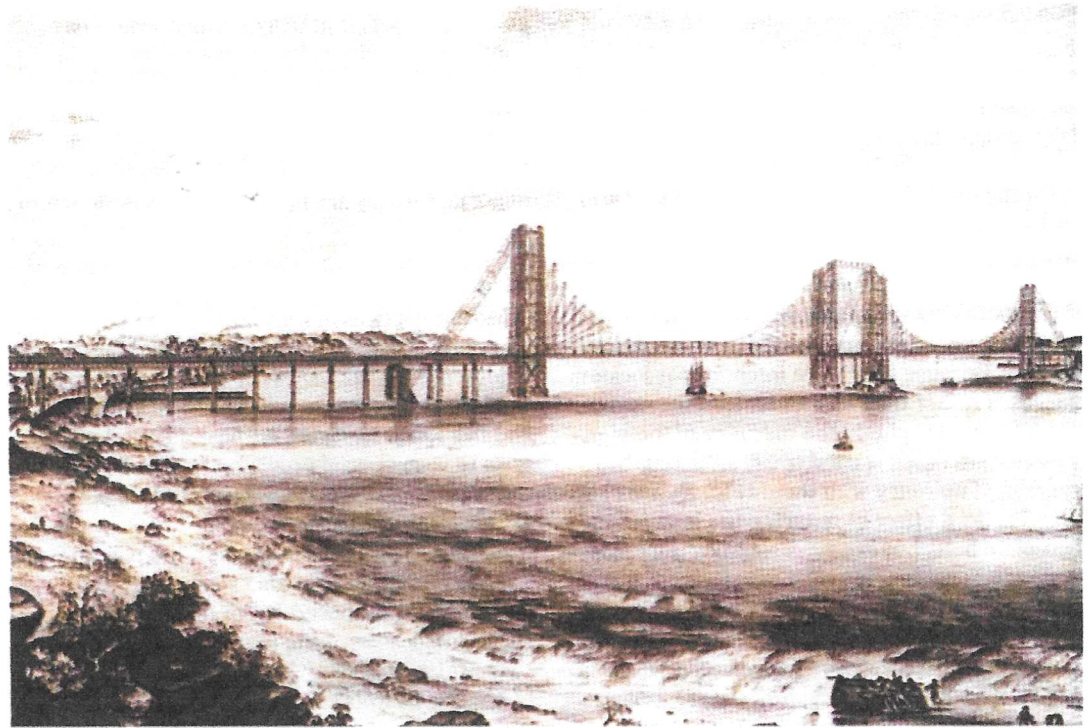
Fig. 9. Bouch's design for the Forth rail bridge prior to the Tay collapse

At the time Bouch redesigned the piers for the Tay Bridge he was also working on the design of the proposed Forth rail bridge (Fig. 9). Because of the magnitude of the spans (488 m) he consulted some eminent engineers of his day (Hawkshaw, Bidder, Pole, Harrison and Barlow) on the question of wind pressure. These engineers in turn, not being satisfied with their judgement, consulted the Astronomer Royal, Sir George Airy. He reported that despite gusts of up to 40 lbf/ft² (1 lbf/ft² = 0.048 kN/m²) acting over 'very limited areas', an average pressure of 10 lbf/ft² acting over the whole length of the bridge was sufficient. This opinion was endorsed by the engineers, who considered the report highly authoritative.
