The legacy of the Tay Rail Bridge Collapse

Iain MacLeod, Tom Martin

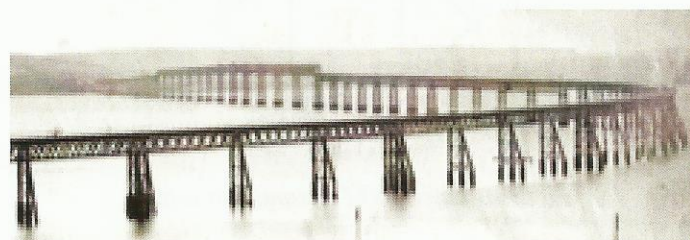
Figure 1. The original bridge

The completed bridge had 85 spans of which 13 were navigation spans - Figure 1. The navigation spans were 'through' girders, i.e. the girders were above deck level so as to provide maximum clearance for navigation. The piers were supported on caissons founded on the 'rock'.

Soon after construction began, it became evident that what had been identified as rock was in many places a thin layer of gravel over clay. The bearing pressures assumed at the bases of the caissons had therefore to be significantly reduced. This meant either increasing the diameter of the caissons or reducing the load on them. Bouch sought to do both and it is here that the seeds of the disaster started to be sown.
